John P. Broomfield
Broomfield Consultants

Consulting Corrosion Engineers

Broomfield Consultants Cathodic Protection Case Histories Page 1 of 5

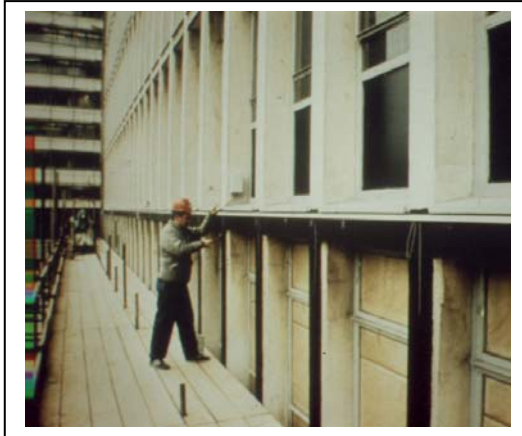
Figure 1a Conductive coating on front face

Case 1 – Structure and Location – Office Building Southend-on-Sea, UK

Cause of corrosion – Calcium Chloride (CaCl_2) set accelerant cast in during construction

Cathodic Protection Description – Conductive organic solvent based coating with protective/decorative top coat

Parties and dates – UK Government building, Taywood Engineering design and install, 1986

Comments – One of the first full scale cathodic protection installations in the UK

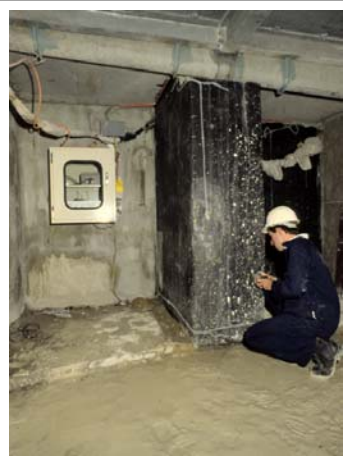
Case 2 – Structure and location – Concrete silo, Western Australia

Cause of Corrosion – salt water ingress

Cathodic Protection Description – Conductive organic coating (chlorinated rubber) used for easy maintenance and repair in industrial environment.

Parties and dates – Designed and installed by Taywood Engineering (Australia) 1987.

Comments – one of the first impressed current cathodic protection installations in Australia

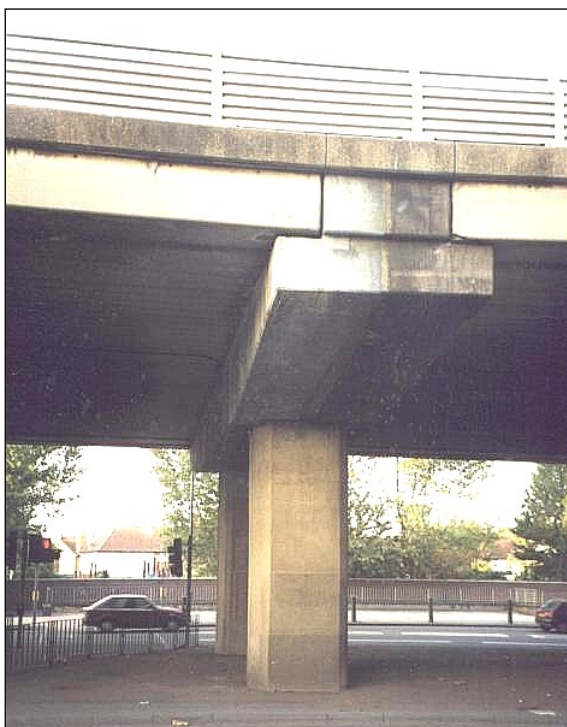
Case 4 – Structure and Location – M4
Elevated section cathodic protection
trials, London
Cause of Corrosion – deicing salts
from winter salting
Cathodic protection description –
cathodic protection trials, solvent and
water based conductive coating anodes,
thermal sprayed zinc and titanium,
mixed metal oxide coated titanium
mesh and conductive mortar.
Parties and dates – Specification John
Broomfield for WSP, (Highways
Agency term consultant), detailed
design and installation Makers UK,
Installed 1996
Comments – severe traffic control
problems.

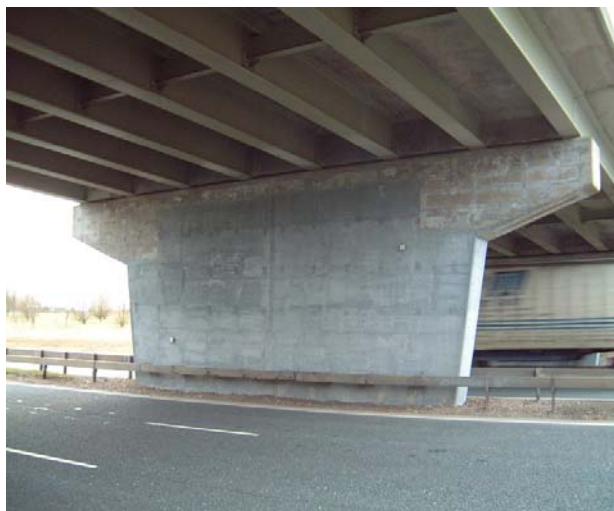
Case 5 – *Structure and location* – Motorway interchange, M6 Cumbria
Cause of Corrosion – Deicing salt leakage through deck joints
Cathodic Protection Description – Arc sprayed zinc anode with probe anodes on cantilevered ends and sheer walls between beams
Parties and dates – Owner, highways agency, consultant AmeyMouchel, outline design and specification John Broomfield, Detailed design and installation Makers UK, installed 2002.
Comments – First major use of arc sprayed zinc system in UK

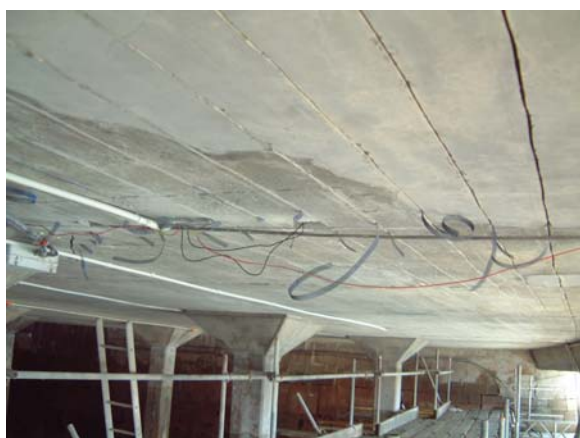
Case 6 – *Structure and location* – New North Quay Jersey, Channel Islands
Cause of Corrosion – Marine salt
Cathodic Protection Description – Mixed metal oxide coated titanium expanded mesh ribbon
Parties and dates – Consultant Jersey Public Services Department, CP Specification, John Broomfield, Installed Brookes (Northern).
Comments – Applied to columns and beams and some soffit areas

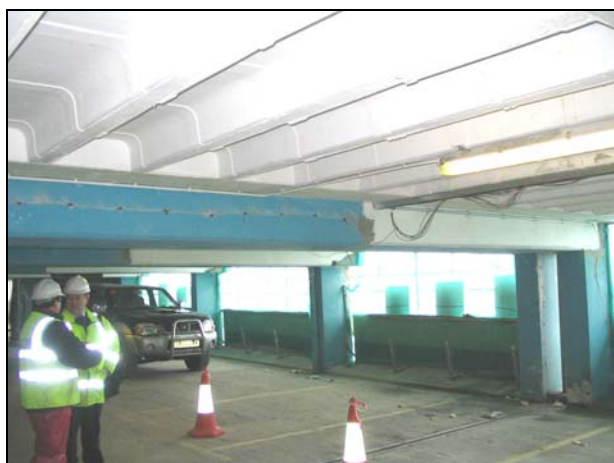
Case 7 – *Structure and location* – Pier Road Multistorey car park, St Helier, Jersey
Cause of Corrosion – Sea salt spray
Cathodic Protection Description – Probe anode installations to selected beams and columns
Parties and dates – Consultant Jersey Public Services Department, CP Specification, John Broomfield, Installed Concrete Repairs Ltd, installed 2005
Comments – selective installation with protective coatings elsewhere provides cost effective corrosion

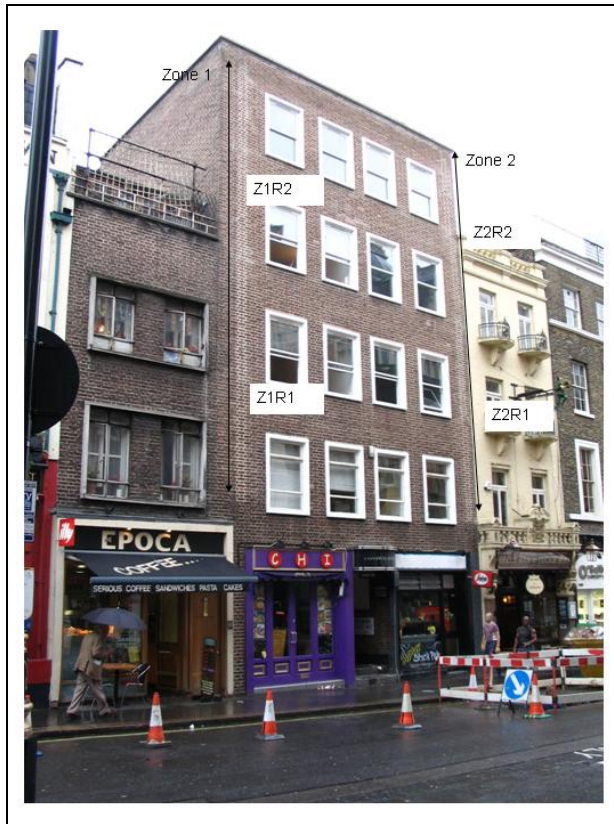
Case 8 – Structure and location – 55-56 St. Martin’s Lane London
Cause of Corrosion – moisture ingress to steel frame in corners
Cathodic Protection Description

–
Mixed metal oxide coated titanium expanded mesh ribbon installed in mortar joints between bricks

Parties and dates – Designed and Broomfield Consultants, Installed by Mannion Construction 2006

Comments – Typical early 20th century steel framed brick clad building system with simple manual control.

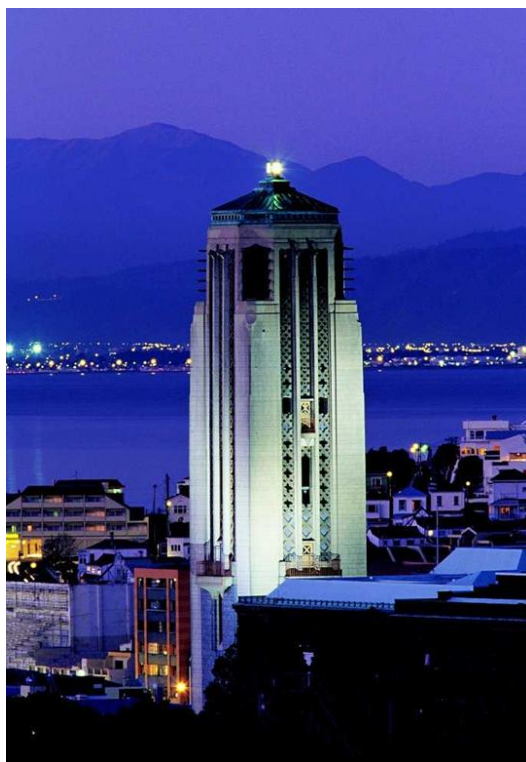
Case 9 – Structure and location – National War Memorial, Wellington New Zealand

Cause of Corrosion – Sea Salt spray through openings in carillon tower

Cathodic Protection Description – Local application of probe anodes to corroding areas.

Parties and dates – Opus International (Australia), Global Corrosion Consultants Ltd., Broomfield Consultants Installed 1999

Comments – Trial and full scale installation with strict deadline for reopening of tower for ANZAC day celebrations . See “Concrete Building Pathology” Ed. Susan MacDonald, Blackwell Publ. 2003 pp 289-293 for further information.

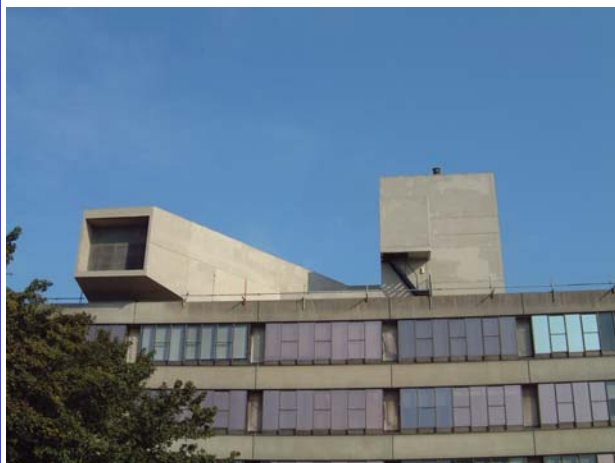
Case 10 – Structure and Location –
University of East Anglia, Norwich UK
Cause of Corrosion – Carbonation,
deicing salts and cast in CaCl_2
Cathodic Protection – Probe anodes
installed inside stair and lift tower,
Silicate coating to external repairs to
moderate appearance
Comments – Grade II historic listed.
See Concrete Society Technical Report
64 Appendix A2 for more information.

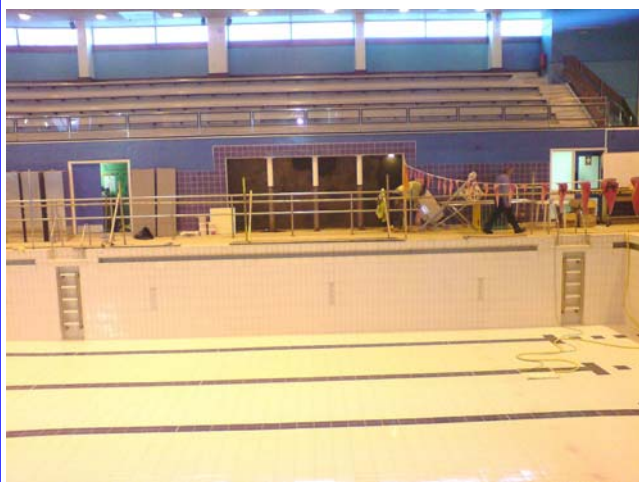
Case 11 – Structure and Location
– Amersham Swimming Pool
Cause of Corrosion – Chloride
ingress
Cathodic Protection – Specialised
Pool anodes to pool sides
Comments – Repairs specified to
achieve water tightness and
coating specification to corroding
steel columns in pool area.

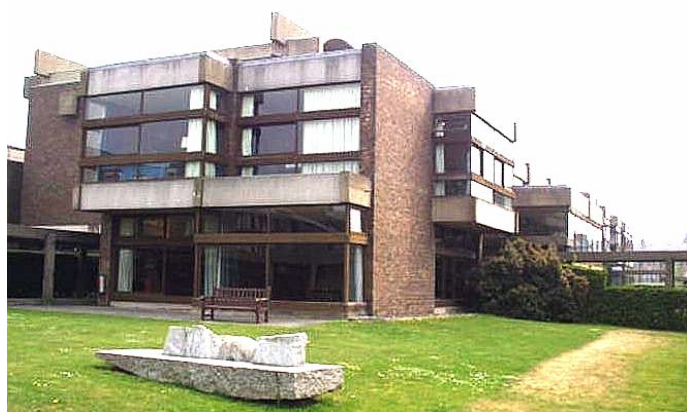
Case 12 – Structure and
Location- Churchill College
Cambridge
Cause of Corrosion – Calcium
Chloride in original concrete
mix
Cathodic Protection – Probe
anodes vertical in structural
fascia beams
Comments – Grade II listed
building
